## Design of Multistress Environment for Cableaging. Implementation of Tan Delta and Partial Discharge test for aged and un-aged High Voltage Cable

**Abstract:** To ensure the continuity of power supply through high voltage cable system, it is very important to determine the insulation quality of a cable system. This paper proposes the techniques for evaluating problem of time to time failures in different tests for solid insulating mediums, so these techniques have used to measure the insulation life and create the aging environment, which involves de shaping and properties of high voltage cable insulation. While creating the desired multi stress environment as an aging chamber which includes the different elements that have pay role in aging. Like acid rain fall, ultra violet radiations and heat plays wide role in the aging. In the designed chamber this multi stress environment has created artificially. Different tests are performed for estimating the condition of cable insulation to check the remaining life of cable .All tests are applied on different samples of XPLE cables having single core  $500mm^2$ , three core  $300mm^2$ , single core  $35mm^2$ , and three core  $120mm^2$

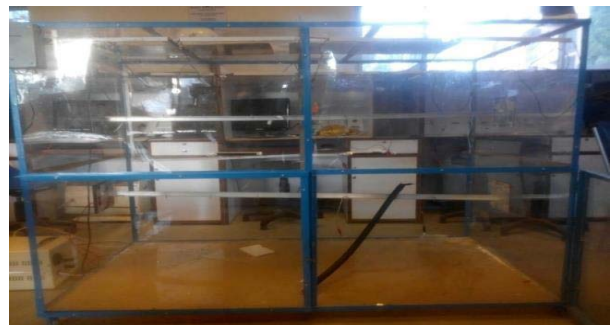
Fig.4. Designed chamber for multi-stress Aging

Multi stress environment is created in form of the chamber using poly methyl methacrylate material normally known as acrylic or Perspex sheets. (Paloniemi, *et. al*, 1990) because of its highly resistivity against most high temperature and very low temperature to make the chamber of the dimensions wit 5'6" length, 4' height and 3' width has sketched in (Fig 3) and shown in (Fig 4).

Rain has a major role in the aging of the cables, to get the rain role we place the shower in the chamber with angle of 45° as sketch in the (Fig 3) and shown in (Fig 4) To rain on the specimen for 22 minutes after every 3 hours of the UV radiations and thermal treatment (Leguenza, *et. al*, 2005). Humidity causes the water treeing in cables insulation, because the entrance of the water in the insulation of the HV cables while energized with the high voltages is cause of the water treeing in the micro or Nano cracks in the insulation of the cable (Markey, *et. al*, 2000). This will later on disturb the electric field and causes disturbances in the insulation and make the way of conduction in the insulator.

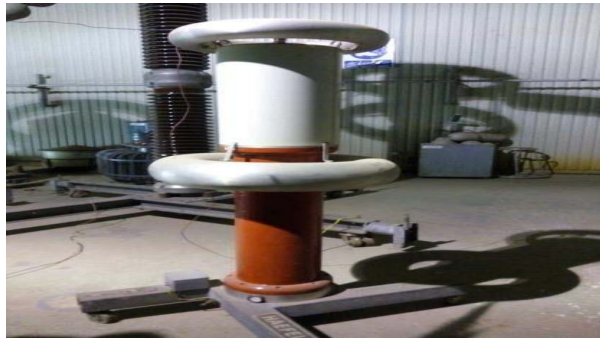
Fig.5. Standard capacitor to balance shearing bridge

Then place the standard capacitor of 100 pF shown in (Fig 5). in the shearing bridge and then set the null point by varying the capacitance placed in bridge from the control desk as shown in (Fig 6). and the connection for the shearing bridge with control desk is shown in (Fig 10) (Ponniran, *et. al*, 2008).

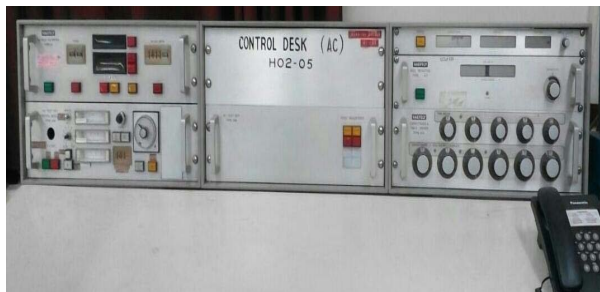
Fig.6. Shearing bridge control desk
